Proposal to improve battery contact in ALAN 441 and ALAN 443

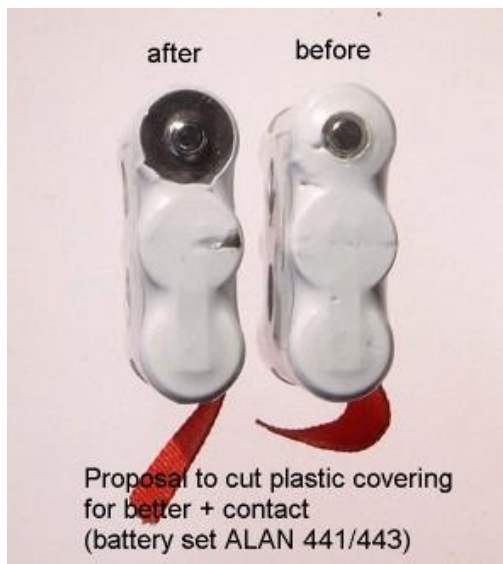
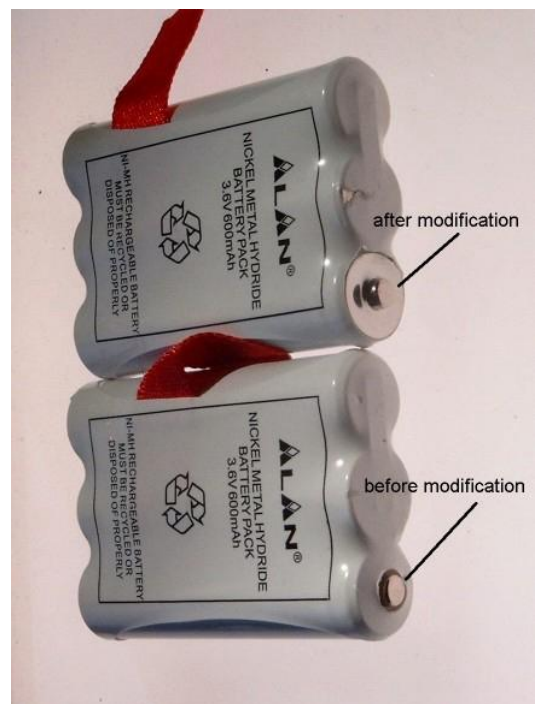
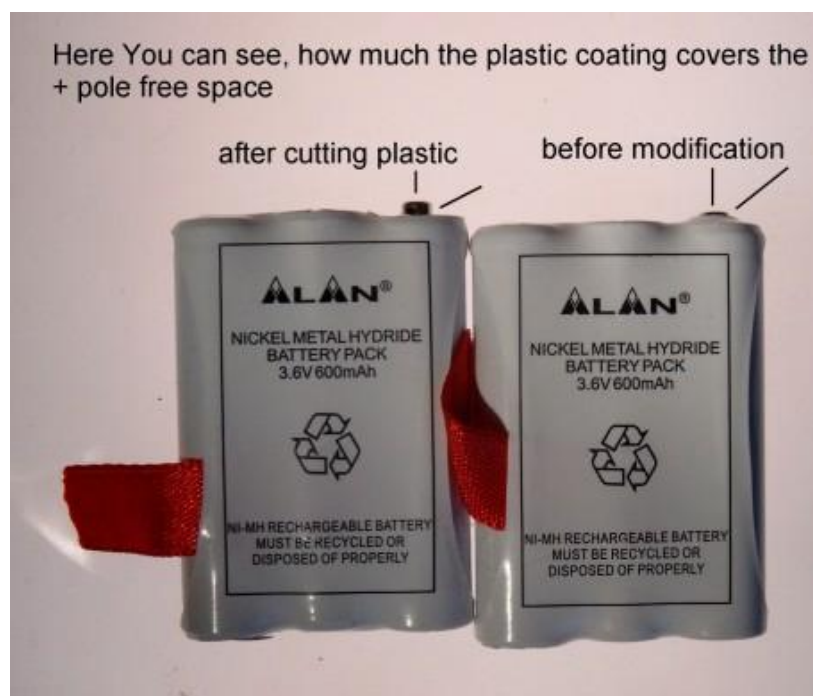
Problem: The NiMH battery pack supplied with the stand charger set has often contact problems when inserting into ALAN 441 and ALAN443. The surrounding of the + contact is covered too much by the white plastic material and does not allow the + contact pin to enter into the gap of the battery contact in the radio's battery compartment.

Solution: Cut the surrounding plastic material around the + contact with a sharp knife. In production take care that the zone around the + contact remains free of plastic.
